PELÉ SOCCER

1560 BROADWAY - THE FORMER EMBASSY THEATER
11.13.18

CARLTON

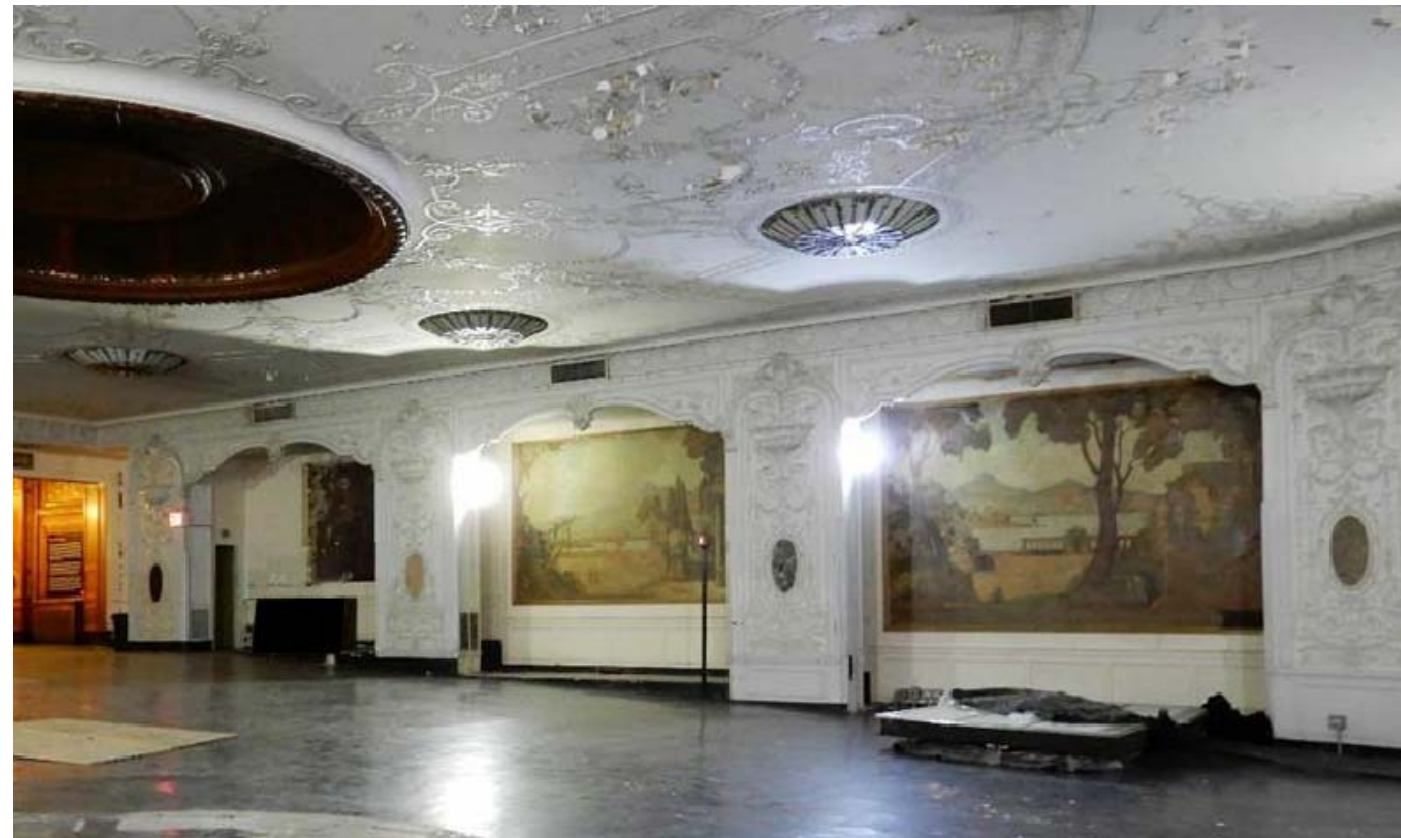
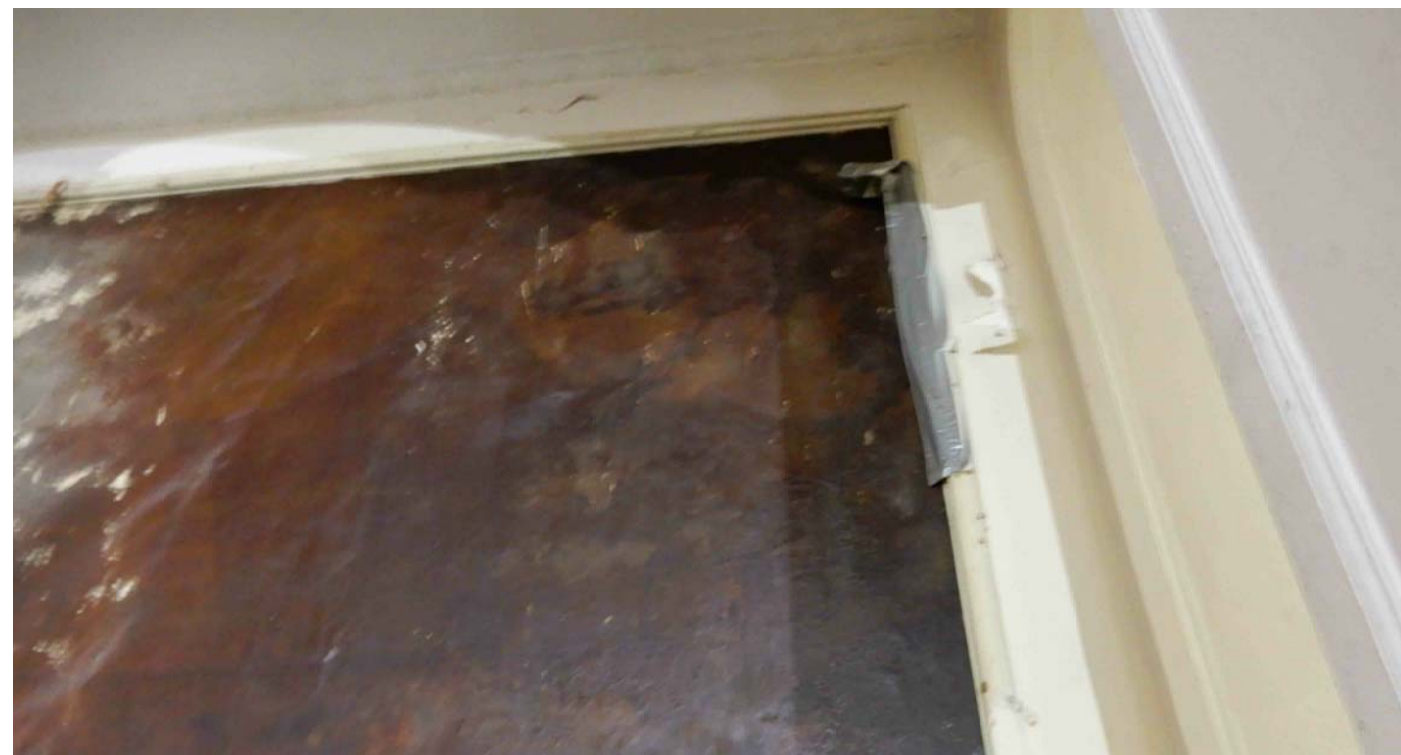
- CLEAN + RESTORE TWO NORTH MURALS
- CLEAN AND INSTALL FREESTANDING HISTORICAL SIGN IN FRONT OF DAMAGED MURALS
- PAINT ALL MURALS FRAMES GOLD
- REPLACE EXISTING MURAL LIGHTING WITH COVE LIGHTS

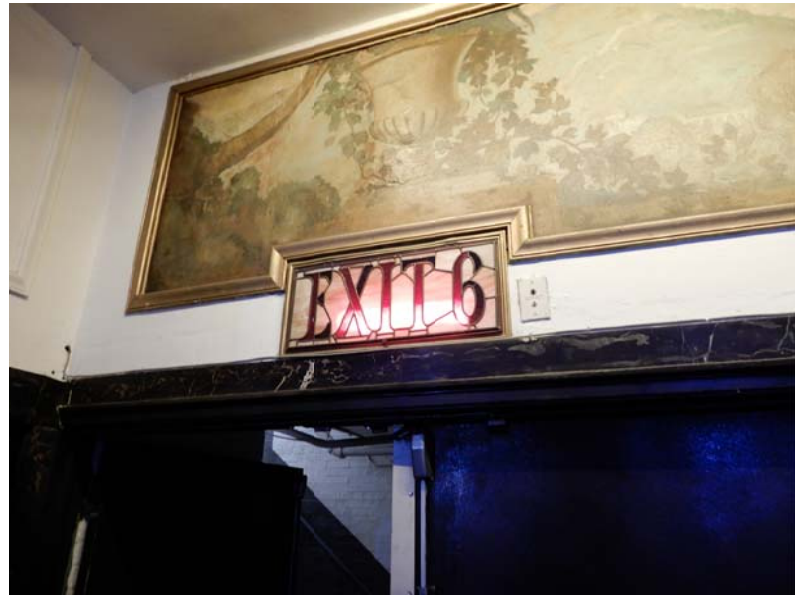
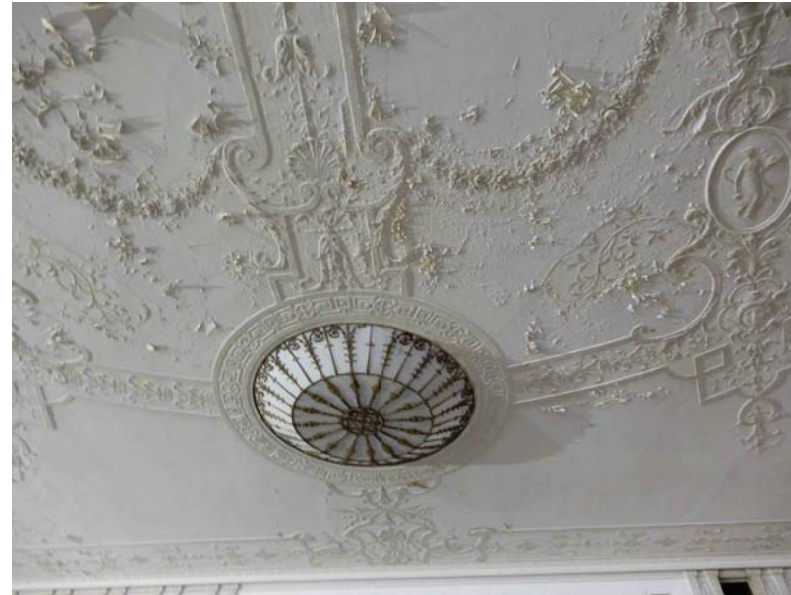
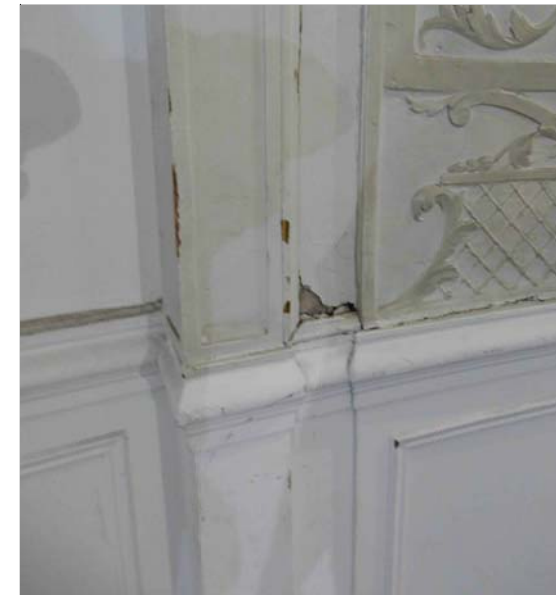
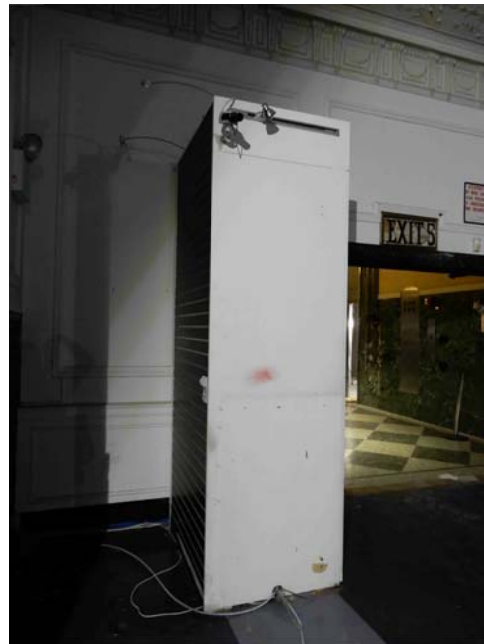
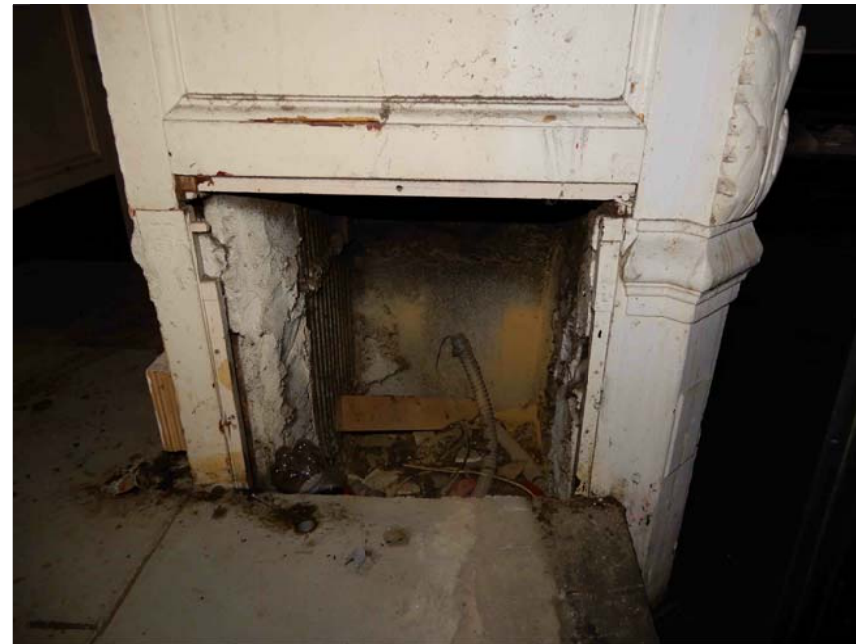
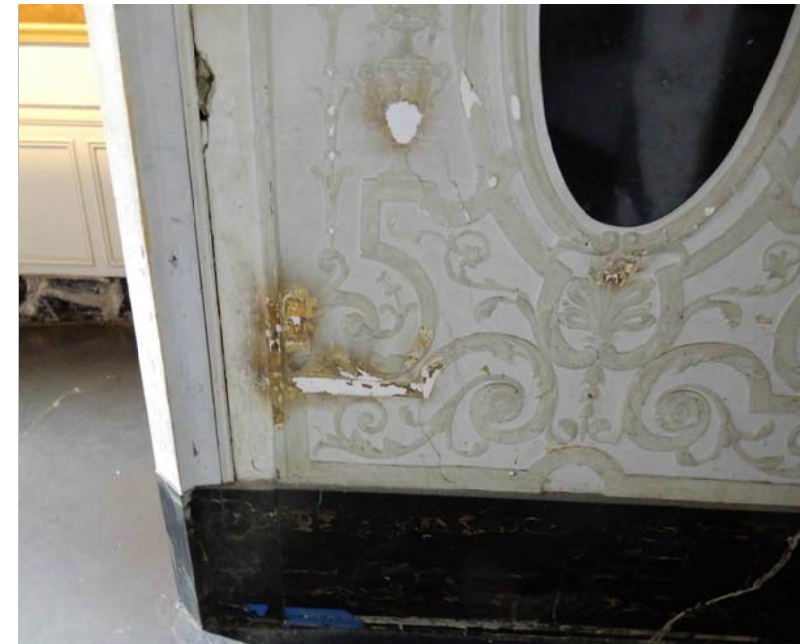
- RE-LAMP AND CLEAN HISTORICAL EXIT SIGNS WHERE POSSIBLE
- PAINT ALL FRAMES OF MURALS METALLIC GOLD
- REPAIR AND PAINT CEILING, RE-LAMP FIXTURES
- REPAIR AND PAINT DAMAGED DECORATIVE PLASTER AND WOOD
- REMOVE ADDITIONS SUCH AS UTILITY CLOSET ABOVE
- REPAIR DAMAGED VENTS AND CHASES

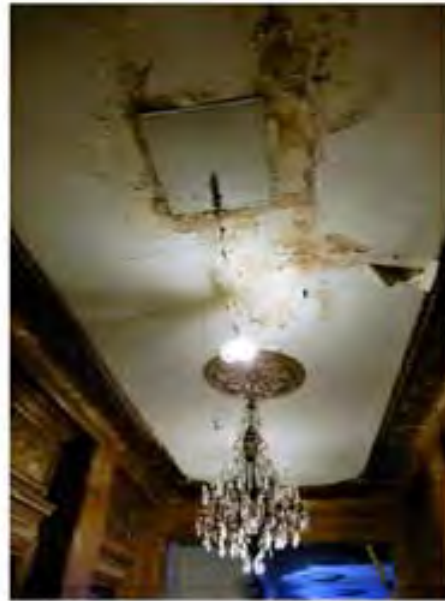
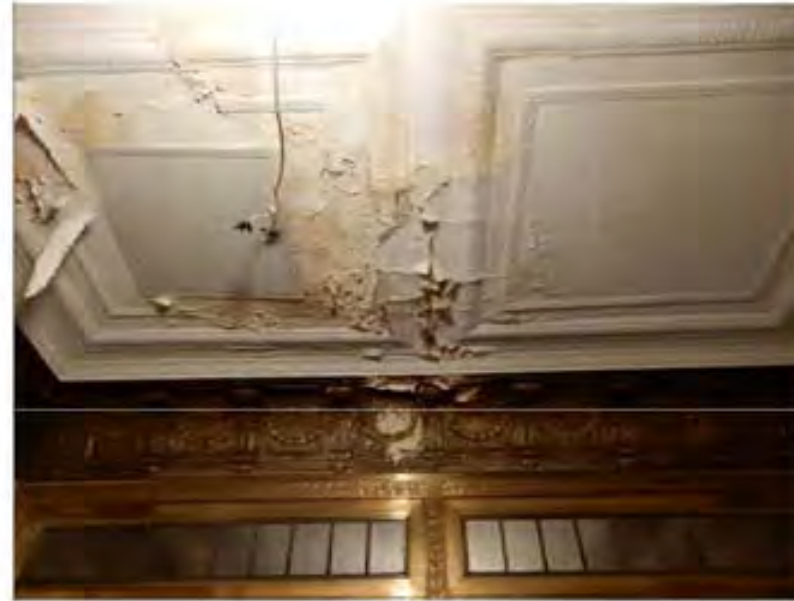
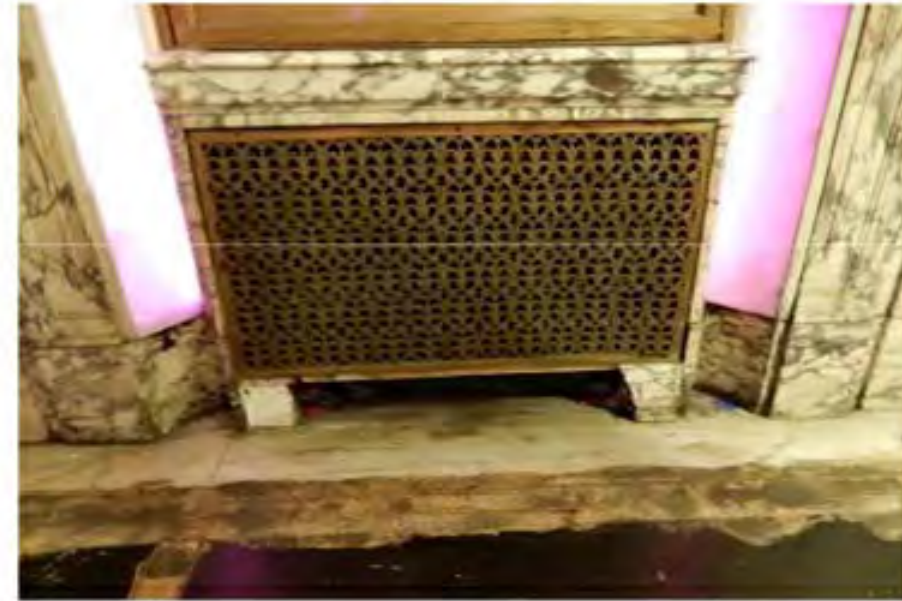
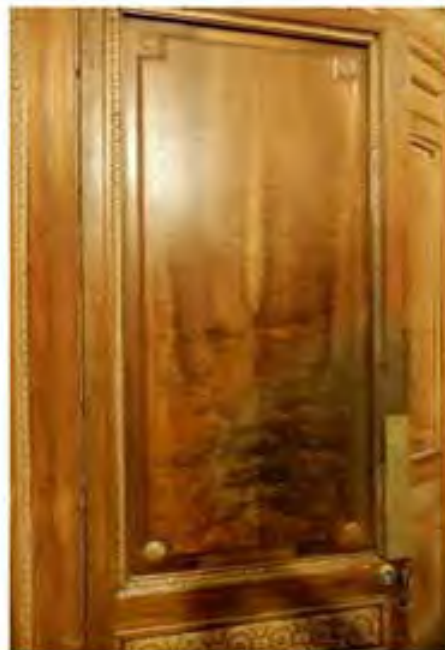
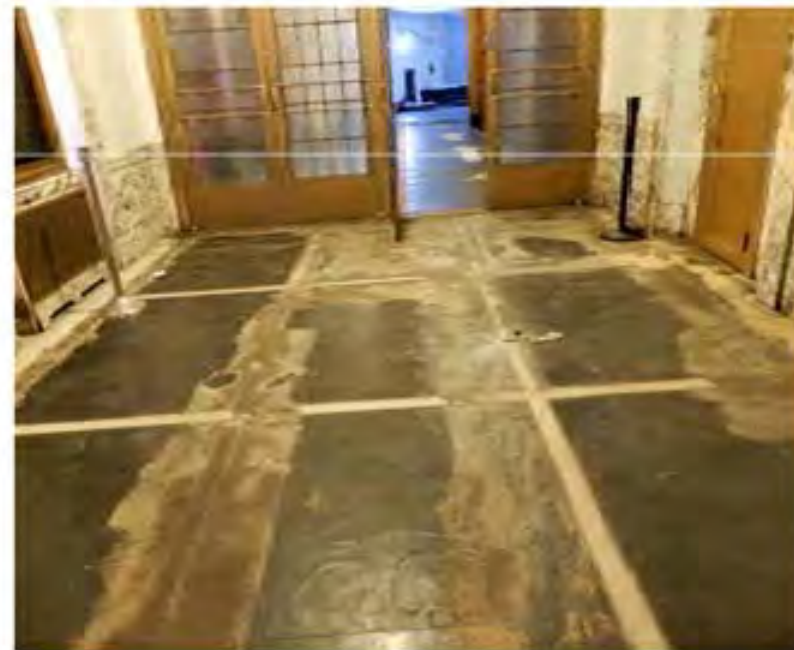
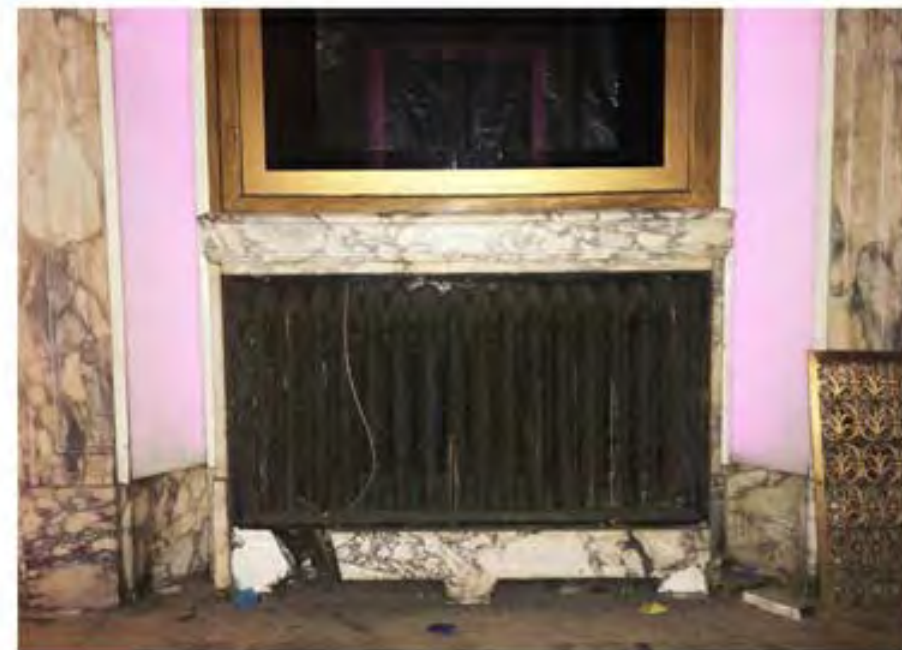
- REPAIR AND PAINT DAMAGED CEILING
- RE-LAMP LIGHTING FIXTURES
- RESTORE MISSING MARBLE AT RADIATORS
- RE-INSTALL DECORATIVE VENT COVERS
- CLEAN & RESTORE STAINED WOOD PANELING
- RESTORE BLACK AND WHITE MARBLE + TILE FLOOR

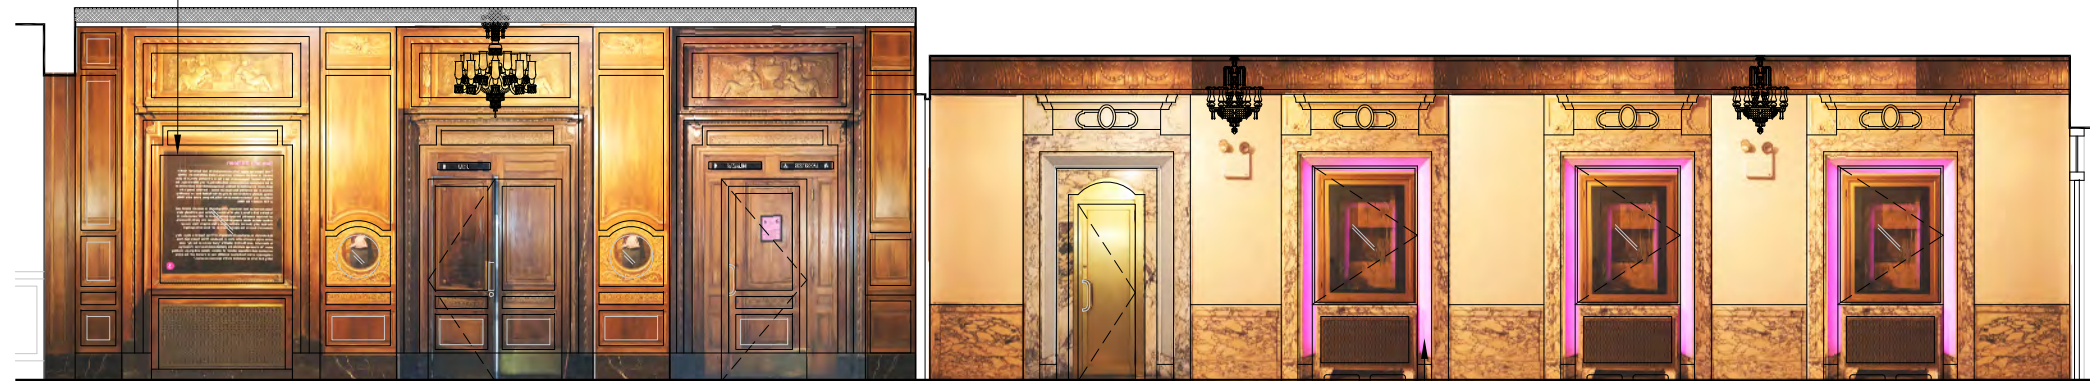
① EXISTING SOUTH ELEVATION

REPLACE EXISTING NEON PINK LIGHT BULB W/ NEUTRAL WARM WHITE LED BULB.

REMOVE EXISTING TEXT
APPLY NEW VINYL
IMAGE OVER MIRROR

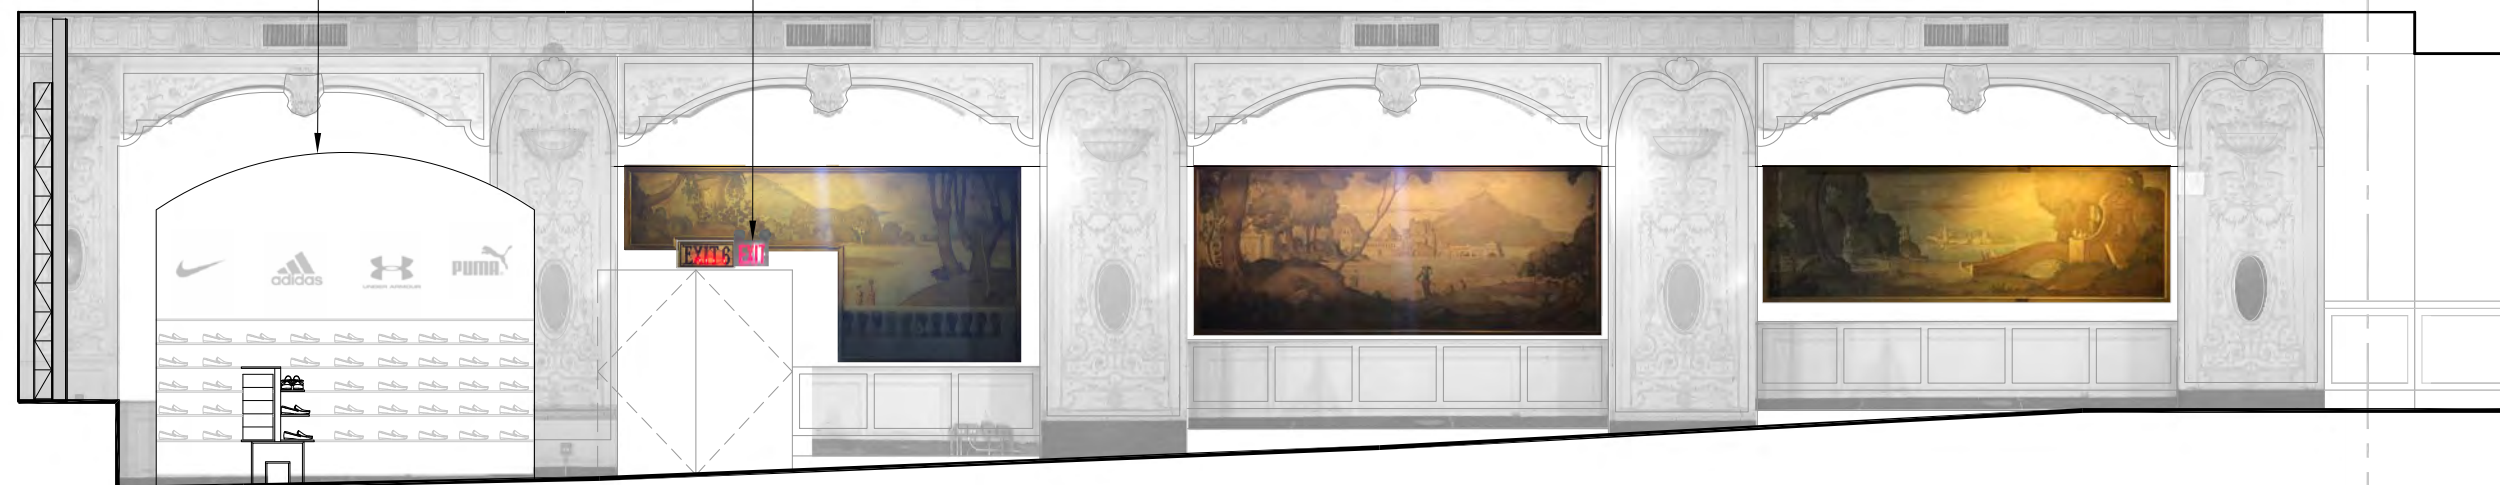
③ PROPOSED SOUTH ELEVATION

FREESTANDING FOOTWEAR
DISPLAY WALL

NEW CODE COMPLIANT EXIT SIGN
